# WELDING INSPECTION REPORT

Resident Engineer: Siegenthaler, Peter **Report No:** WIR-017036 Address: 333 Burma Road **Date Inspected:** 01-Sep-2010

**Project Name:** SAS Superstructure **OSM Arrival Time:** 700 **OSM Departure Time:** 1900 **Prime Contractor:** American Bridge/Fluor Enterprises, a JV

**Bridge No:** 34-0006 **Component:** OBG

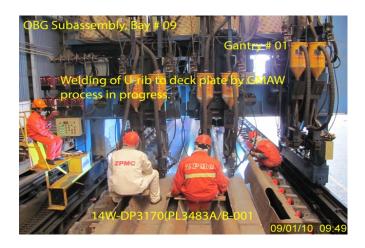
Gas Metal Arc and Submerged Arc Welding (GMAW/SAW) of DP3170-001 in process on gantry # 1. ZPMC Quality Control (QC) is identified as Mr. Zhu Zhong Jie. Weld Procedure Specification (WPS) is identified as WPS-B-T-2342-U1(urib)-5. Welding appears to conform to the requirements of the WPS used. The weld number and welder for respected weld are as follows.

Weld Joint # 001, 009; Welder # 059403 Weld Joint # 002, 010; Welder # 059416 Weld Joint # 005, 013; Welder # 059418 Weld Joint # 006, 014; Welder # 059421

Gas Metal Arc Welding (GMAW) of DP3170-001 in process on gantry # 1. ZPMC Quality Control (QC) is identified as Mr. Zhu Zhong Jie. Weld Procedure Specification (WPS) is identified as WPS-B-T-2342-U1(urib)-5. Welding appears to conform to the requirements of the WPS used. The weld number and welder for respected weld are as follows.

Weld Joint # 003, 011; Welder # 059418 Weld Joint # 004, 012; Welder # 059421 Weld Joint # 007, 015; Welder # 059443 Weld Joint # 008, 016; Welder # 201788
